19th December 2014

International Paints Appraises the Fire Resistance of Protected Steel Rods Subject to Tensile Loading

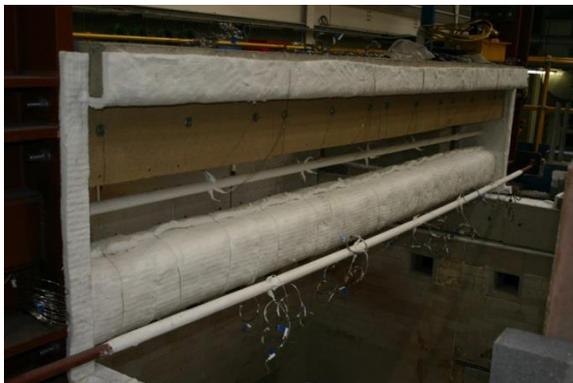
Selected images of test setup (left) and the snapped rod following the fire test (right)

In August 2014 International Paint Ltd's Fire Protection division undertook a full scale fire test of a 6m slender steel rod under tensile loading with an applied intumescent coating. A bespoke tensile loading rig for use in a large floor furnace was designed by International Paints' in-house Structural Engineers to permit this first ever test of its kind.
